## Aviation Accident near Eura Aerodrome on May 17, 2025

L2025-01

## SYNOPSIS

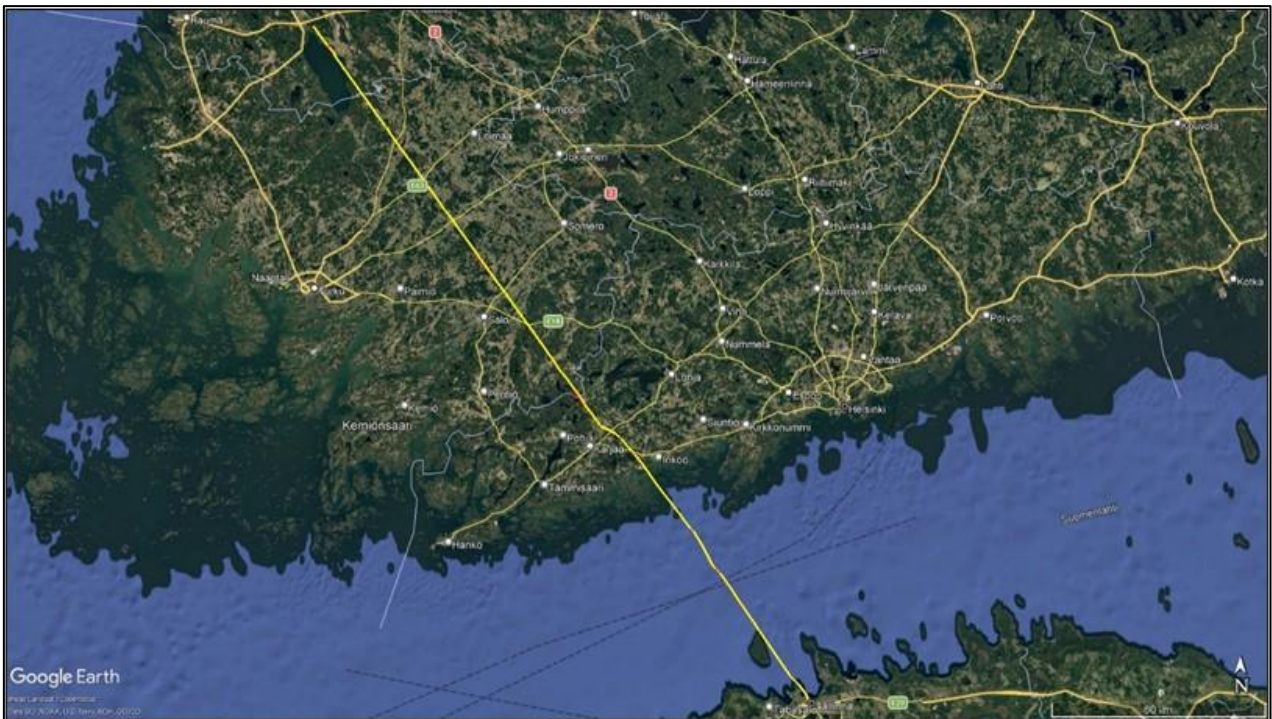
**Figure 1.** Helicopter flight paths. (Image: Google©, annotations: SIAF)

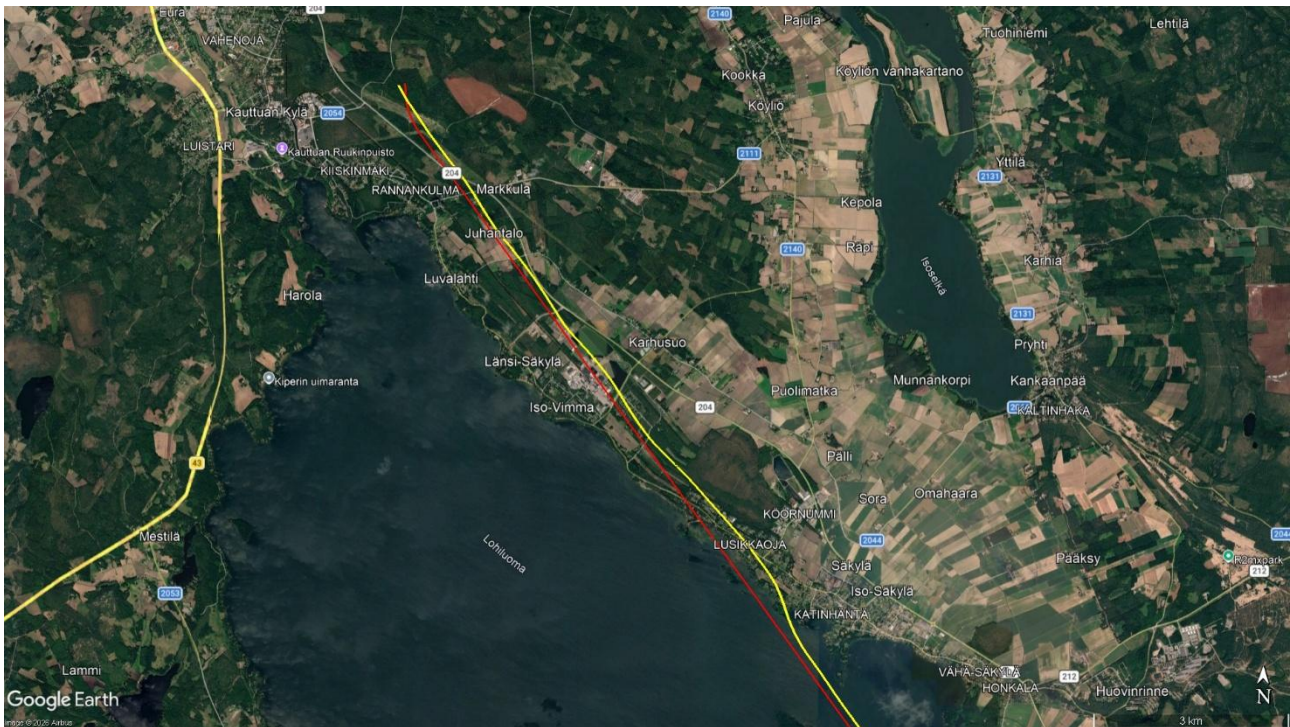
**Figure 2.** The final phase of the helicopters' flight and the collision north of Eura airfield. (Image: Google©, annotations: SIAF)

this time, ES-ETR had turned about 30° to the right and was now positioned behind OE-XOS prior to the impact. The helicopters were substantially damaged and fell to the ground.

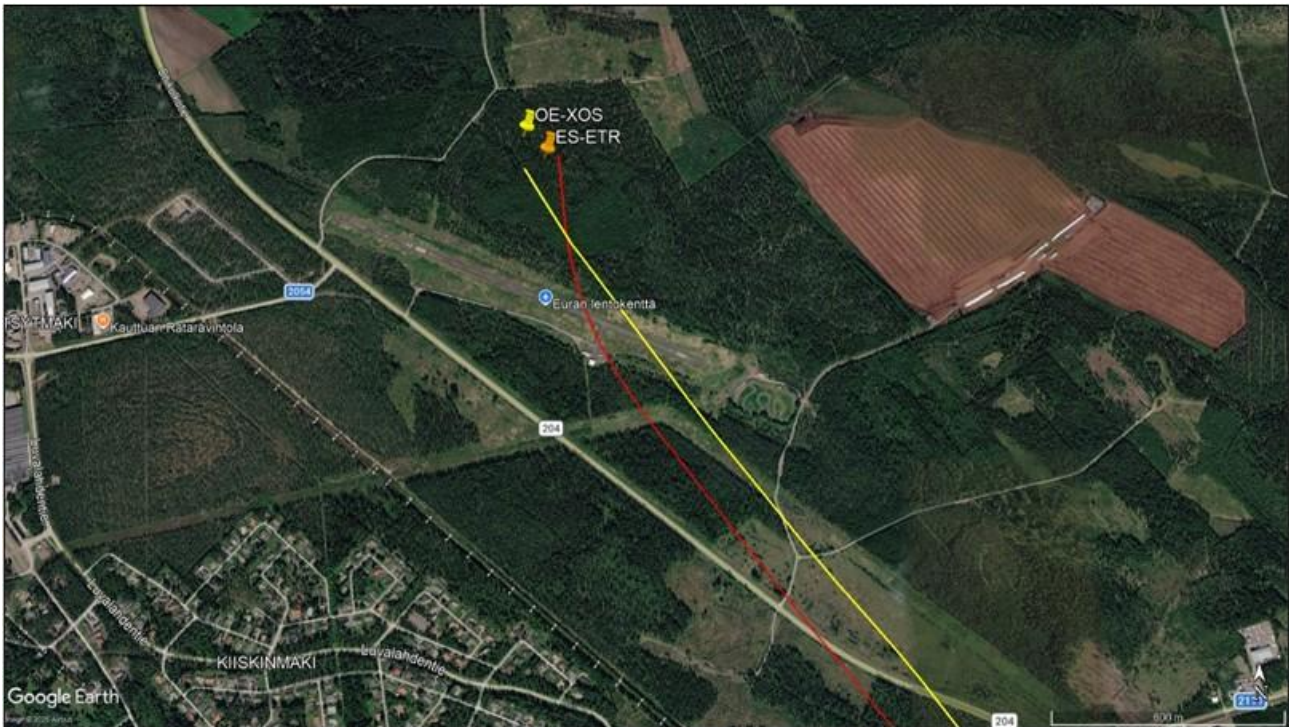
The accident occurred over forested terrain to the north of Eura aerodrome. The helicopters impacted ground a few hundred meters from the runway at the locations shown in figure 3.

**Figure 3.** The accident site. The points where the aircraft fell are marked on the image. The runway at Eura aerodrome is also visible in the image. (Image: Google©, annotations: SIAF)

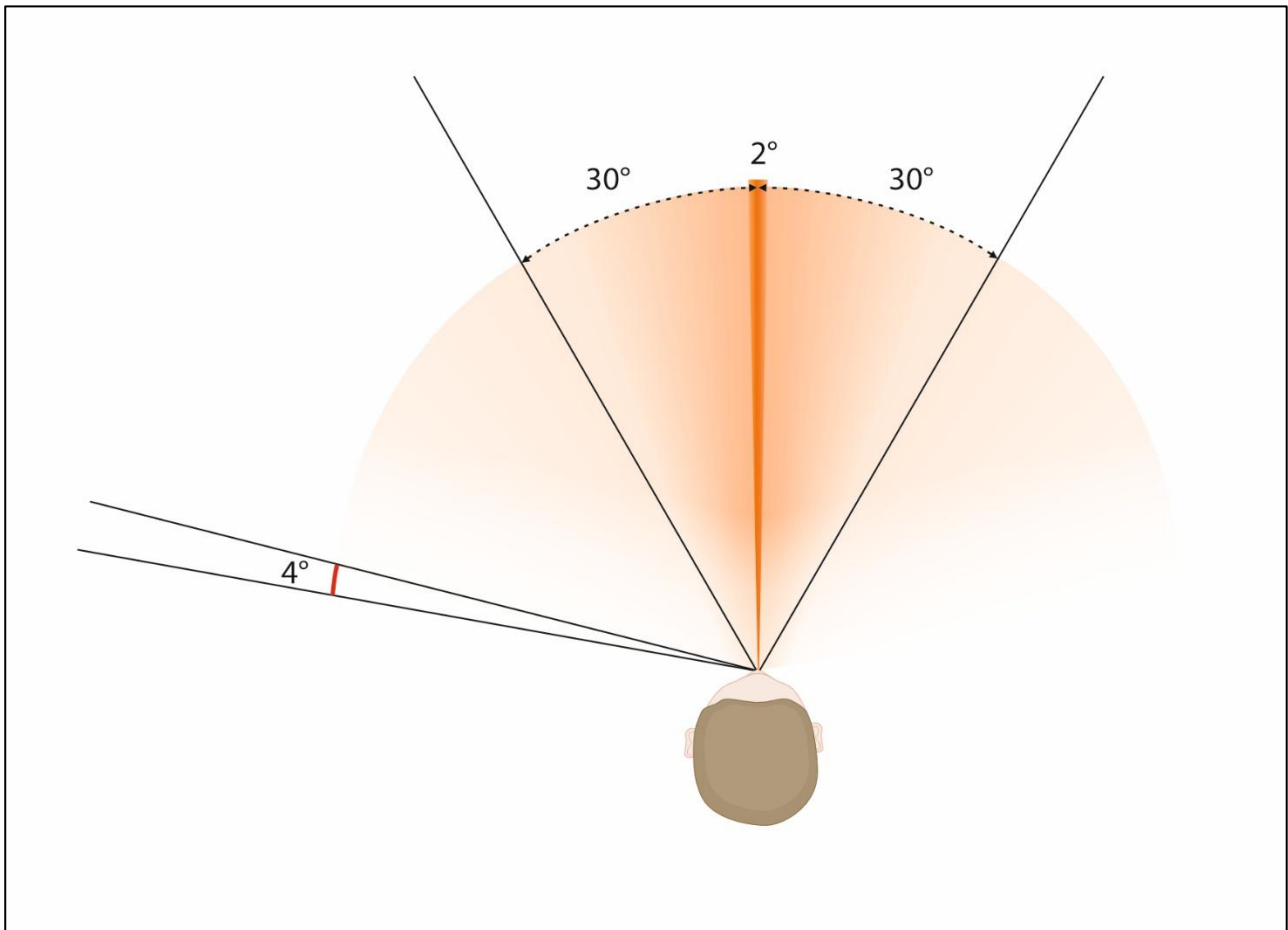
The human visual field spans about 200° horizontally and 135° vertically. However, visual acuity and object detection differ across the visual field in which the central, focal point covers a sector of no more than about 1° to 2°. Outside this small area of sharp vision in the center the eye, visual acuity degrades gradually until at an angle of about 30°, degradation is significant. The area outside this sector is referred to as the area of peripheral vision in which the visual system can detect primarily broad shapes and objects that are sufficiently high-contrast, i.e., stand out from the background, while most details are not distinguished.<sup>19</sup>

**Figure 15.** Extent of human visual field. Details can only be seen of objects within the focal point covering a narrow arc of about 1° to 2° on either side of the center of the eye. Outside this sector, visual acuity degrades gradually until within the area of peripheral vision at an angle of about 30° straddling the focal point degradation is significant. This area is referred to as the area of peripheral vision. The figure shows the apparent size (about 4° of line-of-sight angle) of an R44 at a distance of some 125 m from the viewer. (Figure: SIAF)

R44 at various ranges within the viewer's visual field, indicated as degrees of the line of sight angle to visualize the extent of coverage of the aircraft in the viewer's visual field. When seen from the side, the R44 is about 9 m long, and the area of its main fuselage is about 4 x 4 m. When ES-ETR initiated the shallow right-hand turn, separation between the helicopters was about 125 m. At this distance, the angular size of each helicopter within the pilot's visual field was no more than about 4° (see figure 15), and less than 2° with the tailboom excluded.

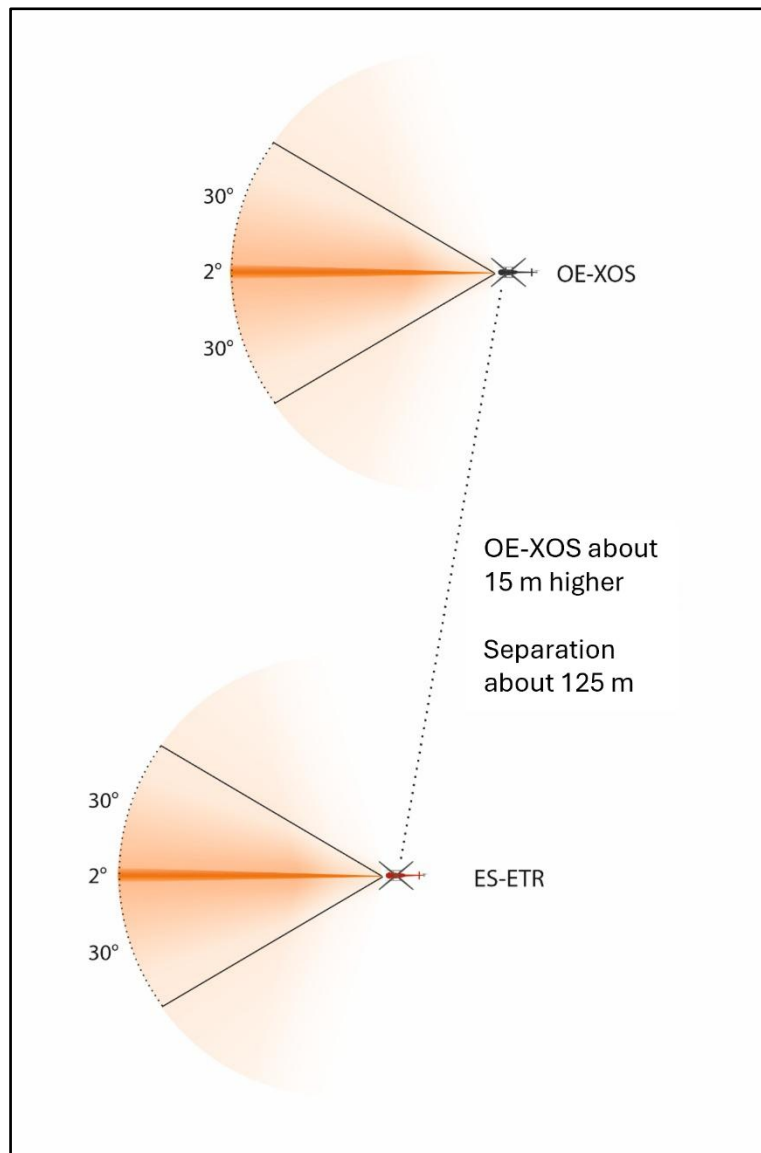
**Figure 16.** The extent of the pilots' visual field when looking straight ahead. The figure shows the helicopters' relative position just before ES-ETR initiated the turn. (Figure: SIAF)

When ES-ETR entered the shallow right-hand turn it was in front of OE-XOS on the left side and slightly below (see figure 16). The pilot and passenger of OE-XOS occupied the right and left front seat, respectively. It is possible that the cabin roof and door frames obstructed the view from ES-ETR's cabin in the direction of OE-XOS, while in OE-XOS, view to the left toward the position of ES-ETR could have been limited by the front seat passenger and door frames. As the turn continued, ES-ETR moved aft as seen from OE-XOS, and as a result the left seat passenger would have obscured the view significantly.

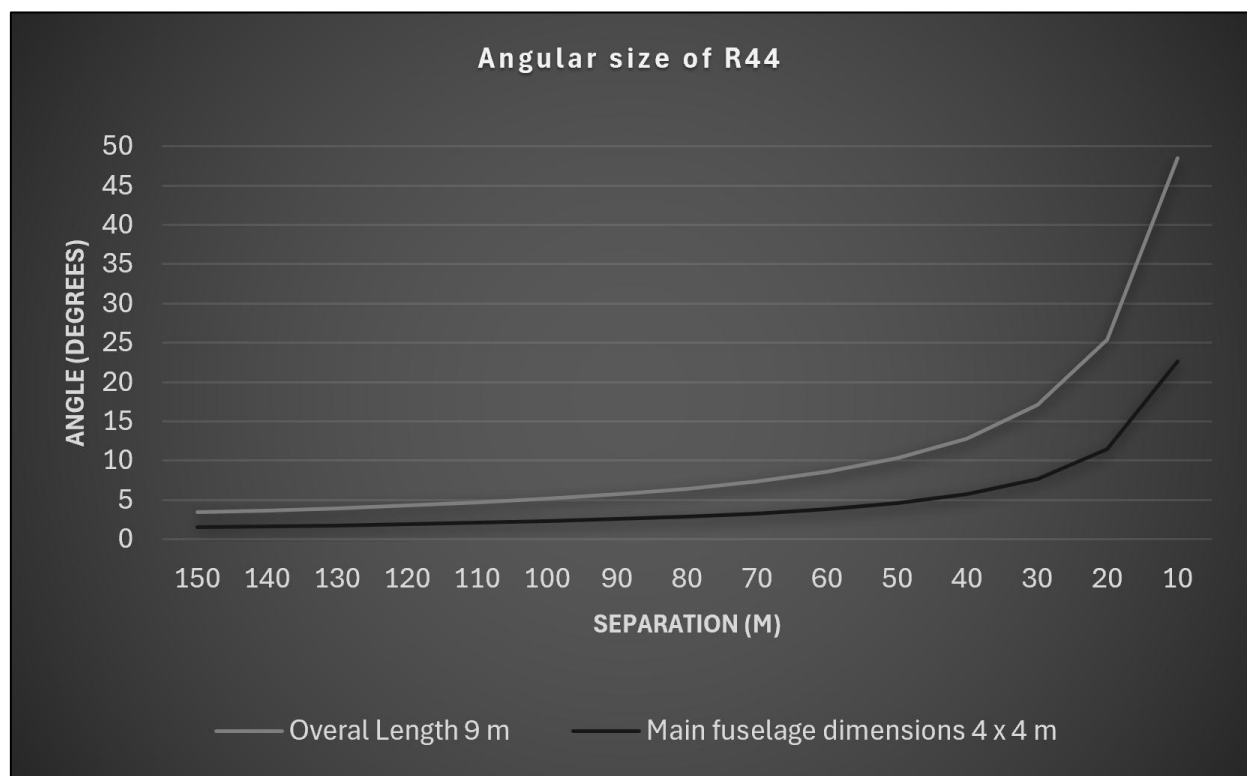
While the relative size of an oncoming aircraft increases gradually within the viewer's visual field as the range closes, this increase is not immediately significant in situations where an aircraft approaches from a long range at high speed. Figure 17 shows the angular size of an

In order to distinguish details of an object of this size, the viewer must look directly at the object. Relative size does not begin to increase until during the final seconds before collision. As shown in the figure, still 3 seconds before the impact the angular size of the helicopter was no more than about 10°, and only about 5° with the tailboom excluded.

**Figure 17.** Angular size of the R44 versus range in degrees of visual field. (Figure: SIAF)

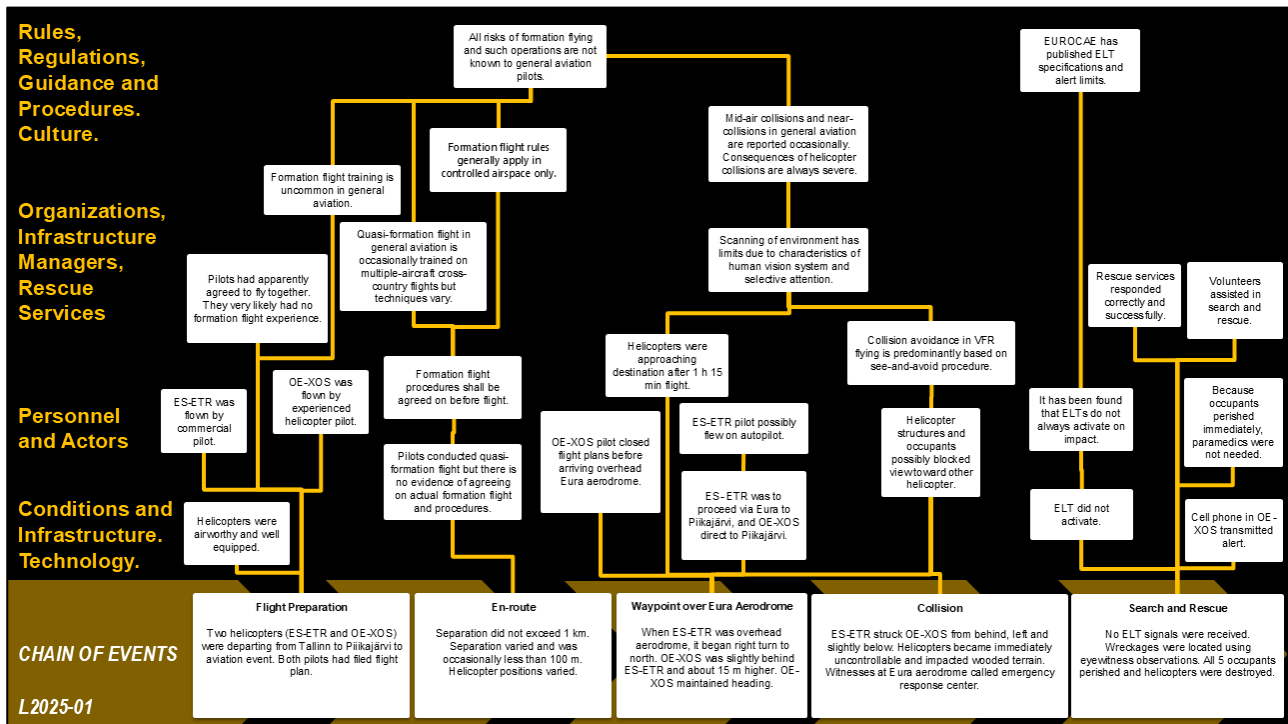
A SIAF-developed format of the AcciMap approach<sup>30</sup> was used to support the analysis of the occurrence. The following text is arranged in accordance with an AcciMap diagram created during the investigation. The occurrence is depicted as a chain of events along the bottom of the diagram. Contributing factors at various levels can be examined by moving up and down the diagram.

Figure 20. AcciMap diagram, investigation L2025-01. (Figure: SIAF)
