# Collision of Airplane with Ground Power Unit at Helsinki Airport on August 16, 2025

L2025-02

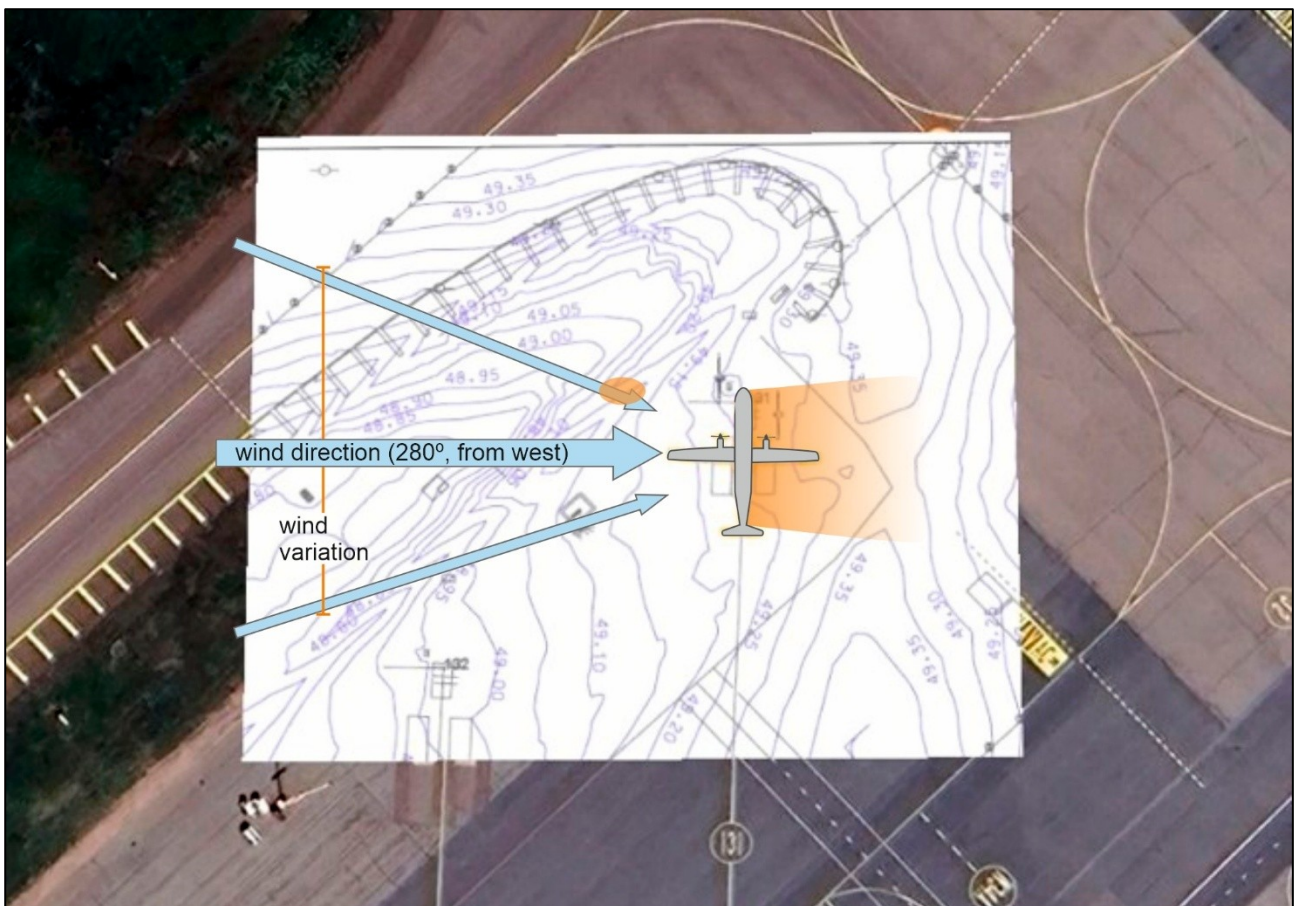
Propeller and GPU fragments scattered over a large area. A piece of aluminium GPU chassis was found about 250 m away near stand 29. Brisk westerly wind contributed to the spreading of fragments. The largest piece, a propeller blade section over one meter long, was projected high over the airplane and landed about 30 m from the fuselage and next to the dispatcher. The substantially damaged airplane and GPU were subsequently repaired for re-entry into service.

**Figure 7.** Wind direction and variation. Areas where most debris was located are shown in orange. (Photo: Finavia and Google Earth, annotations SIAF)

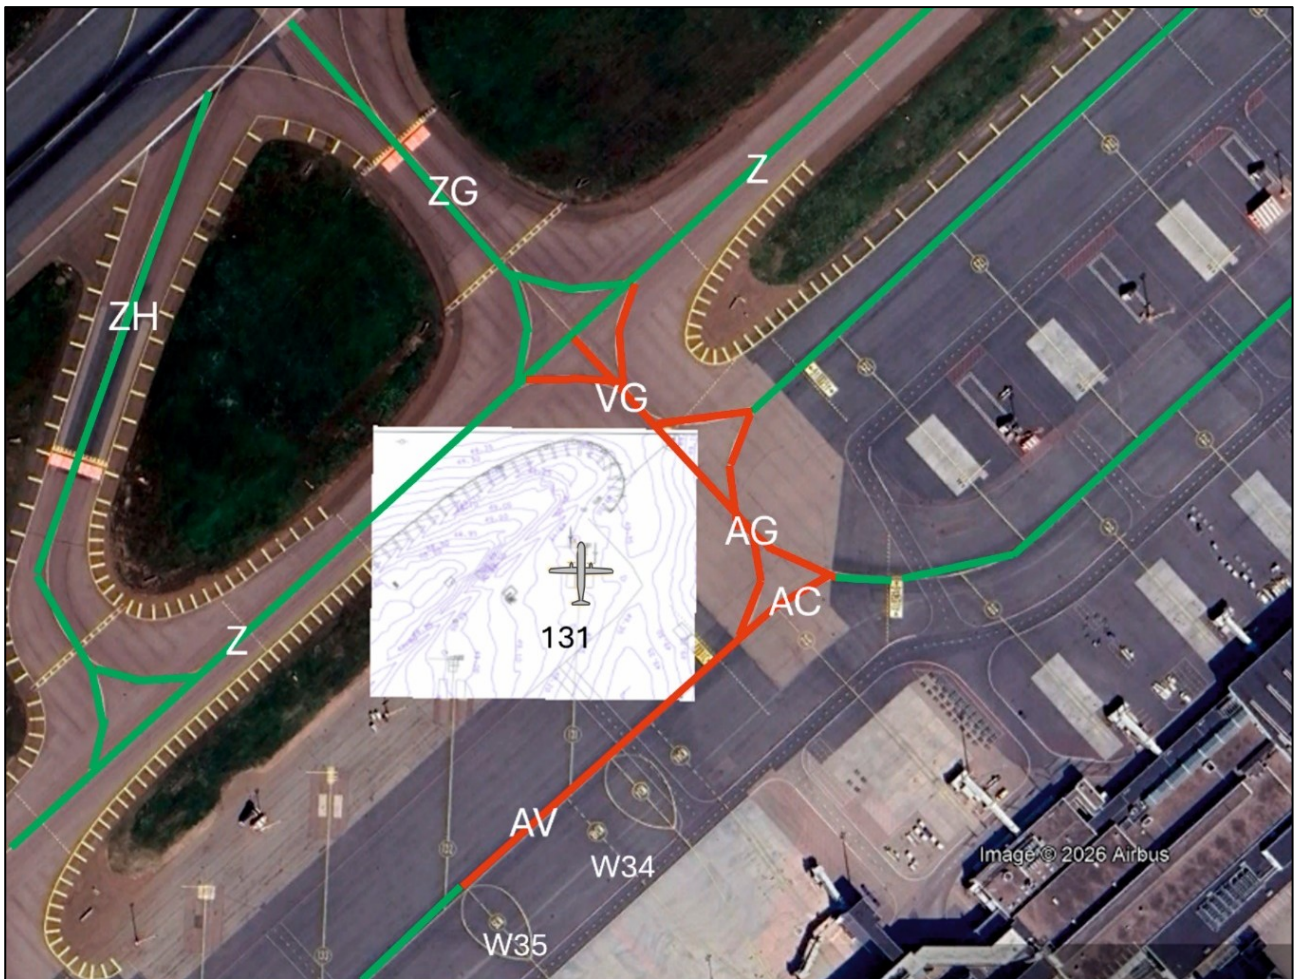
During the post-occurrence inspection, the marshaller found debris on taxiways VG and AV from abeam stand W34 to taxiway VG and proposed that ATC close the taxiways from abeam stand W35 to taxiways AV, AG and WG.

**Figure 8.** Taxiways closed immediately after the occurrence are shown in red. (Photo: Finavia and Google Earth, annotations SIAF)

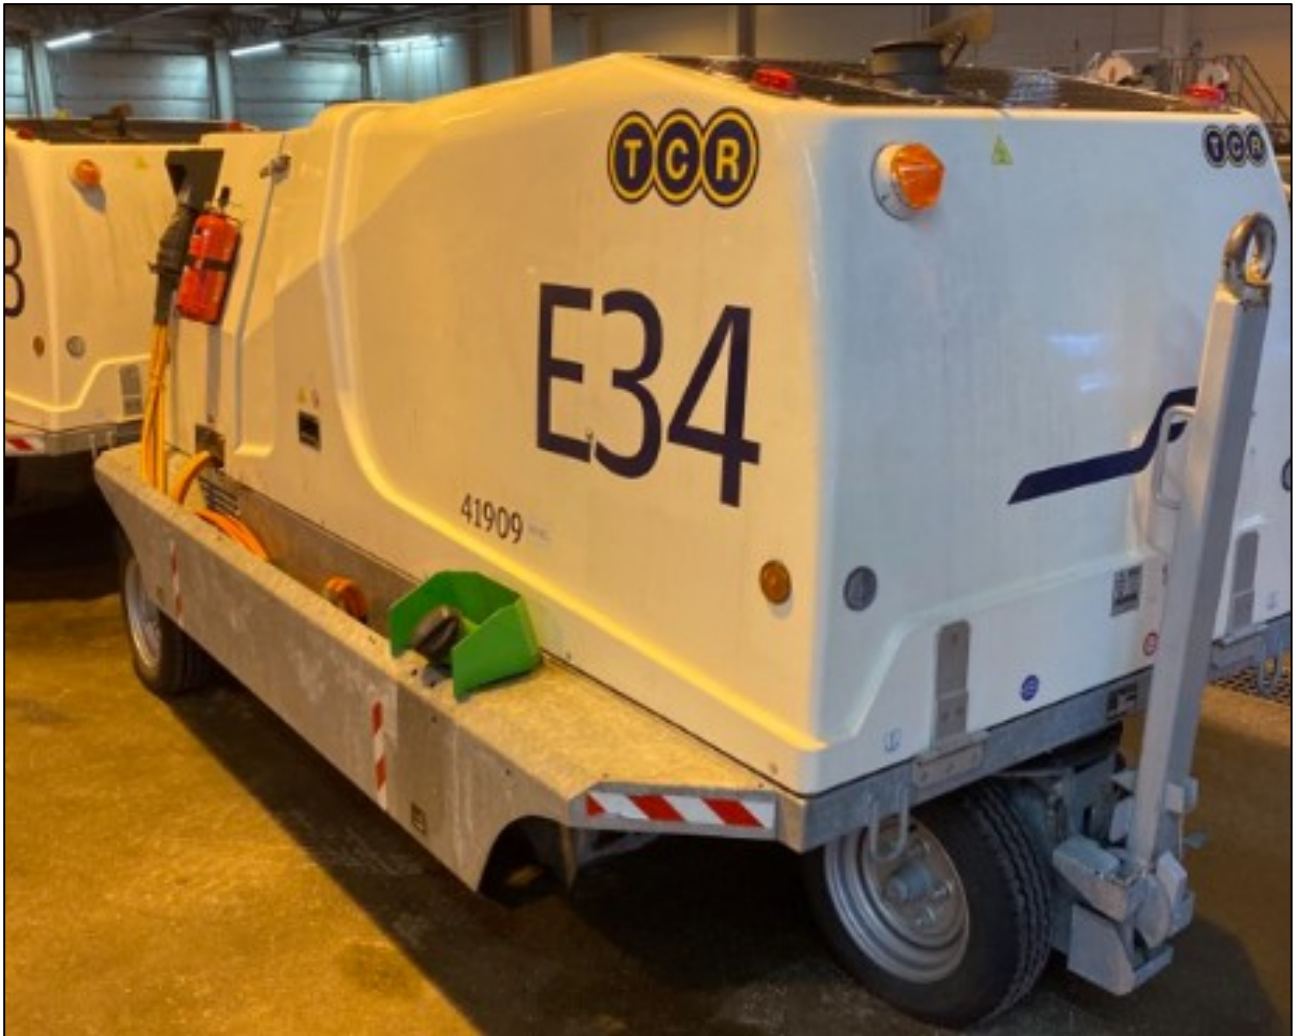
**Figure 9.** Guinault GA90 ground power unit. (Photo: TCR Finland)
