Aircraft Accident Investigation Commission

FINAL REPORT AIRCRAFT ACCIDENT INVESTIGATION

COPTERLINE OY SIKORSKY S-76C+

**In Tallinn Bay, Estonia
on 10 August 2005**

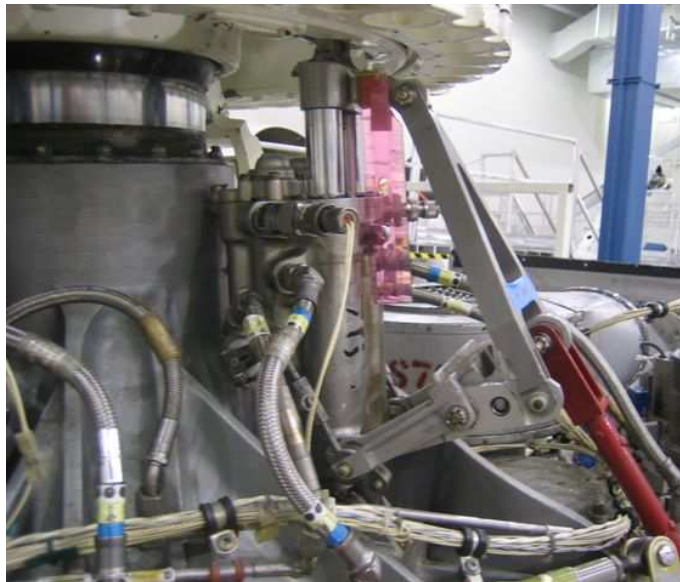
Photo3. Forward main rotor actuator installation on the helicopter

According to the maintenance records, the pistons installed in the main rotor forward actuator in the last overhaul had been in service for 24 100 hours. As the stripping of the aluminum-bronze coating on the pistons was a requirement in an overhaul, it might be assumed that there had been seven reworks of the pistons. However, according to Sikorsky, the pistons were not reworked more than three times.

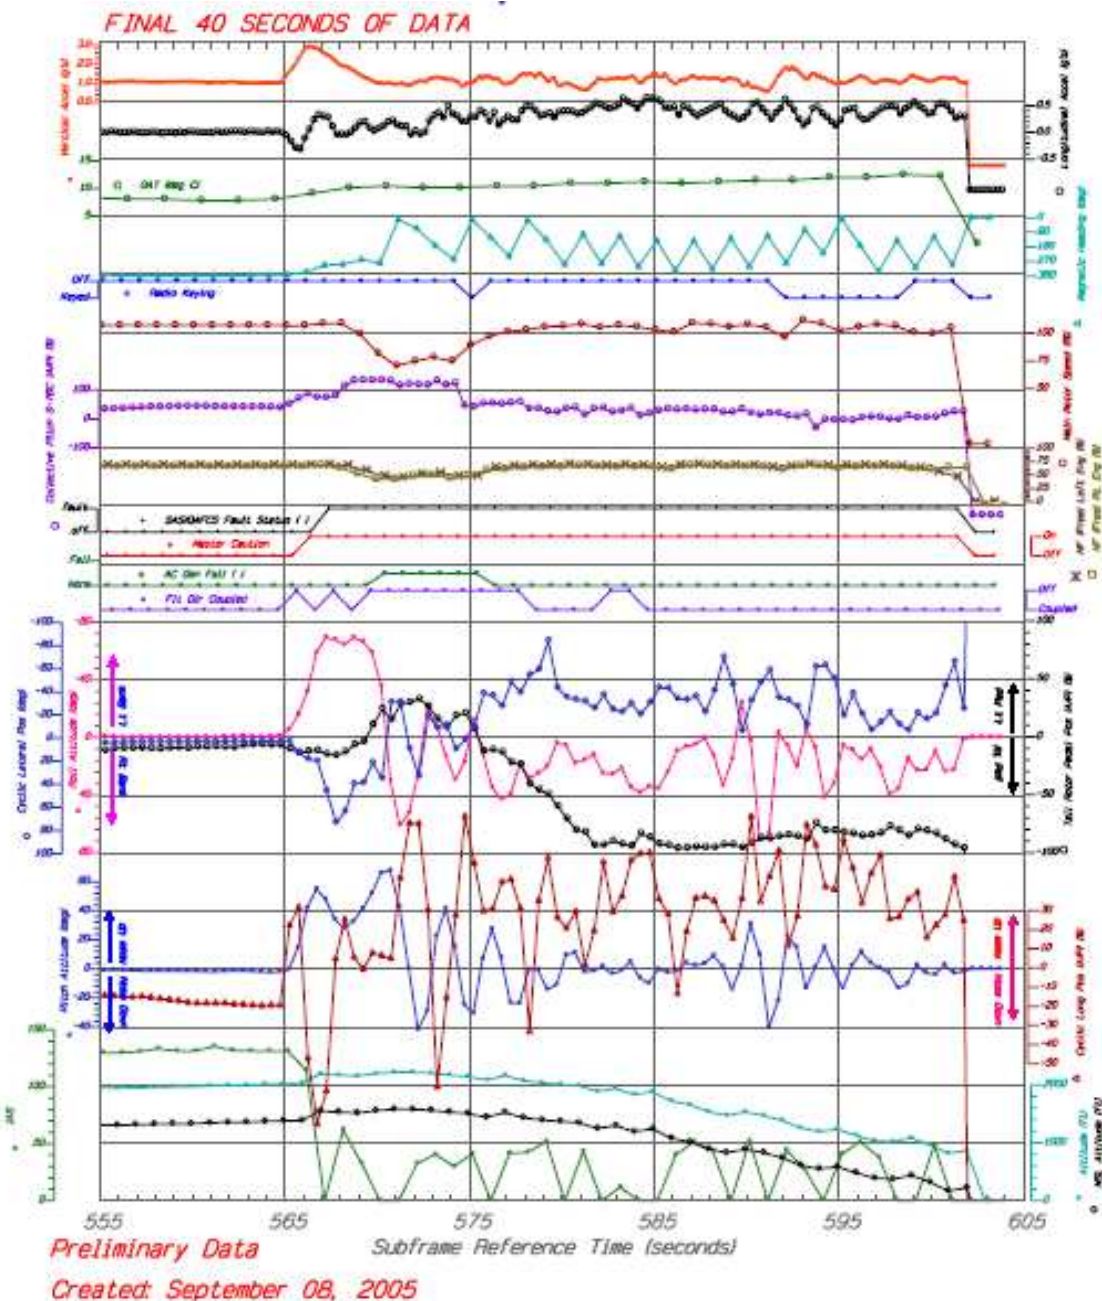
Figure 2. FDR data of the last 40 seconds of the accident flight

At 12:41:50 hours, according to the FDR data, five seconds after the power increase, the cyclic control moved rapidly aft over half of the maximum travel and the collective control started to move up. The attitude of the helicopter changed rapidly. It pitched up abruptly and rolled to the left. Following the initial upset flight condition, according to the FDR data, the helicopter began a rotation to the right with significant oscillations in pitch and roll attitudes.

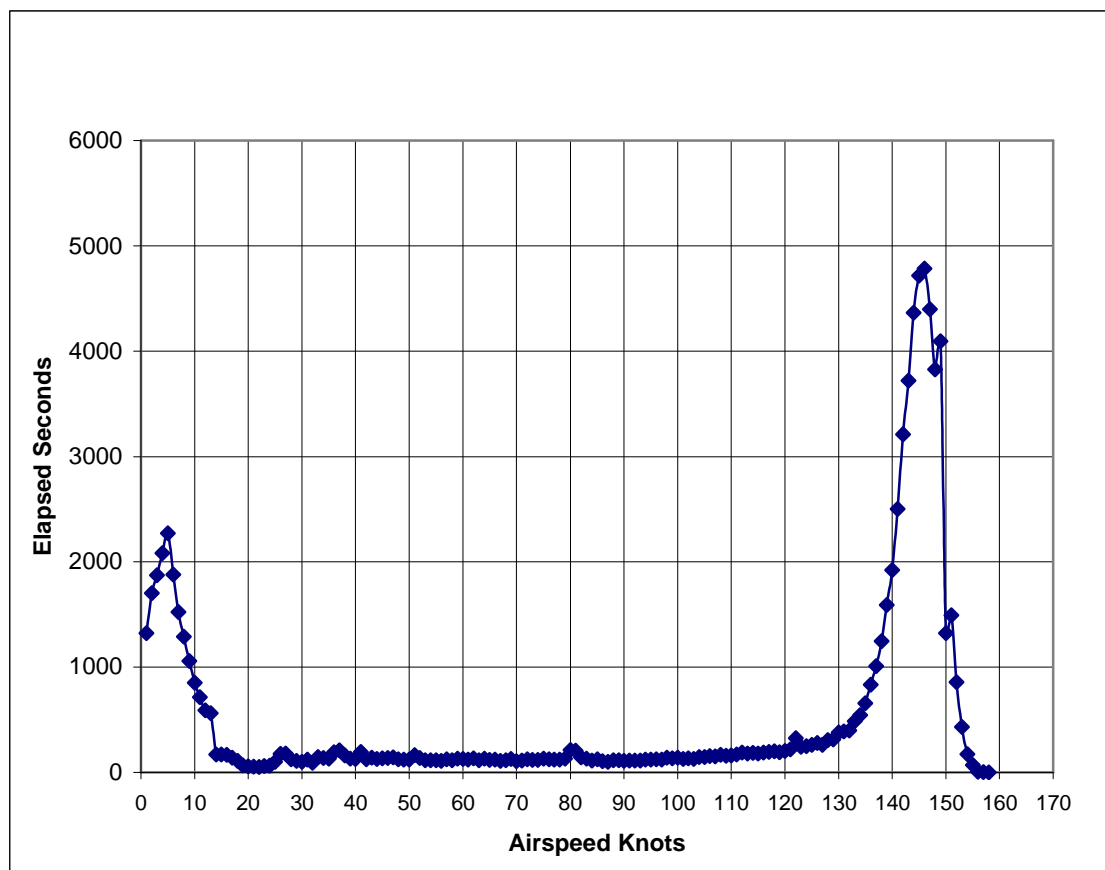
The FDR data (33 hours) was used extensively in analyzing the events on the accident flight and the previous flight to Tallinn, as well as analyzing events on flights and ground runs in the days preceding the accident. The airspeed distribution showed that half of the flight time was within 10% of the 155 kt Vne and 82 seconds were at or exceeding Vne, i.e. Copterline had reached or exceeded the maximum speed (Vne) certificated for the helicopter for a short time period during nearly every flight in the recording.

Figure 3. Airspeed distribution from the 33 hours of FDR data. Redline speed (Vne) was 155 kt.

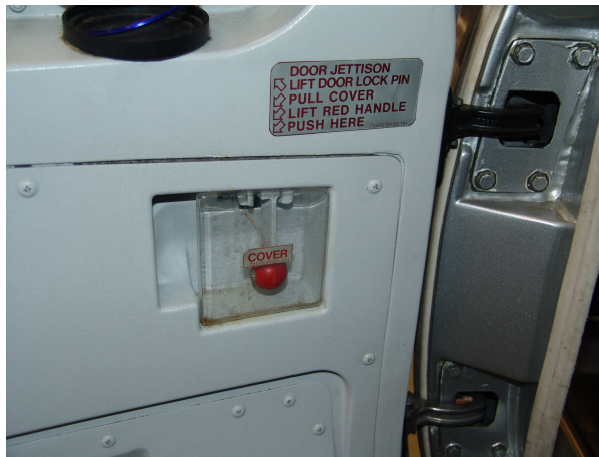
Photo 6. S-76 Co-pilot door (left side)

In order to open a helicopter door by the emergency procedure, it was necessary to pull out a door lock pin, to raise the cover of the jettison handle, and to turn the jettison handle from the horizontal position to vertical. No attempt had been made to jettison the right side cockpit door or the passenger cabin doors. According to the divers, the left side cockpit door fell easily out its frame; the door lock pin had been pulled, the cover of the jettison handle had been raised and the handle had been turned to the upright position, but the door had not been pushed out.

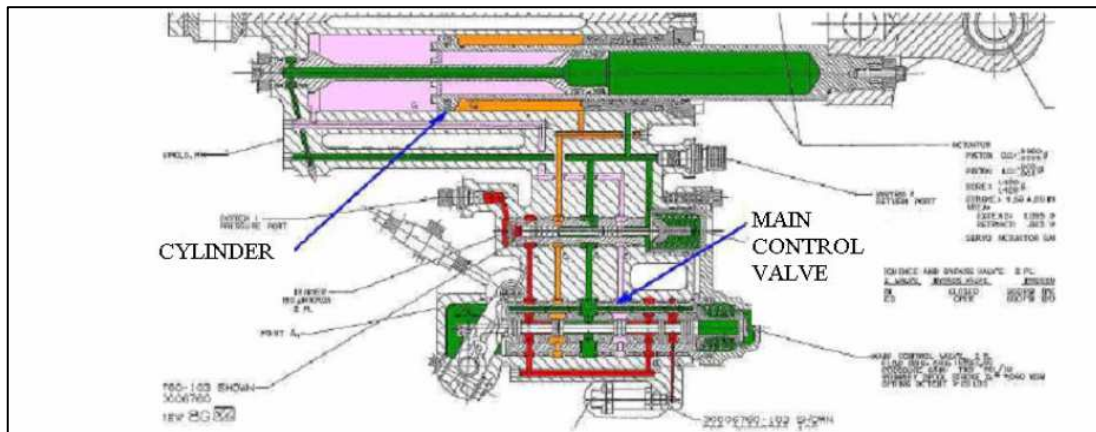
Figure 6. Main rotor actuator hydraulic schematic (one system).

The forward actuator was inspected and functionally tested at HSI in Trumbull, Connecticut, USA in accordance with the procedures in the Component Maintenance Manual 67-15-01. Visual inspection of the actuator found no external defects. Functional testing of the actuator found that it did not meet the Acceptance Test Procedure (ATP) requirements in several areas (the ATP was used for both newly manufactured and overhauled actuators).

The maximum allowable leakage for an in-service actuator was 725 ml/min. System no. 2 leakage at the Null position measured 2400 ml/min, and system no. 2 leakage with a hard-over Extend command measured 1800 ml/min. Also, the actuator did not remain at the full Extend position; it had a tendency to back off the stop unless force was applied to pilot input. With only system no. 2 energized, the actuator then stopped responding at the extended position and it did not retract when pilot input was moved to the full Retract position. Restoring system no. 1 and continued cycling on both systems and operation freed the restriction noted above. The system no. 1 leakage at the hard-over Retract position measured 2700 ml/min, and the system no. 2 leakage at the hard-over Retract position measured 1120 ml/min.

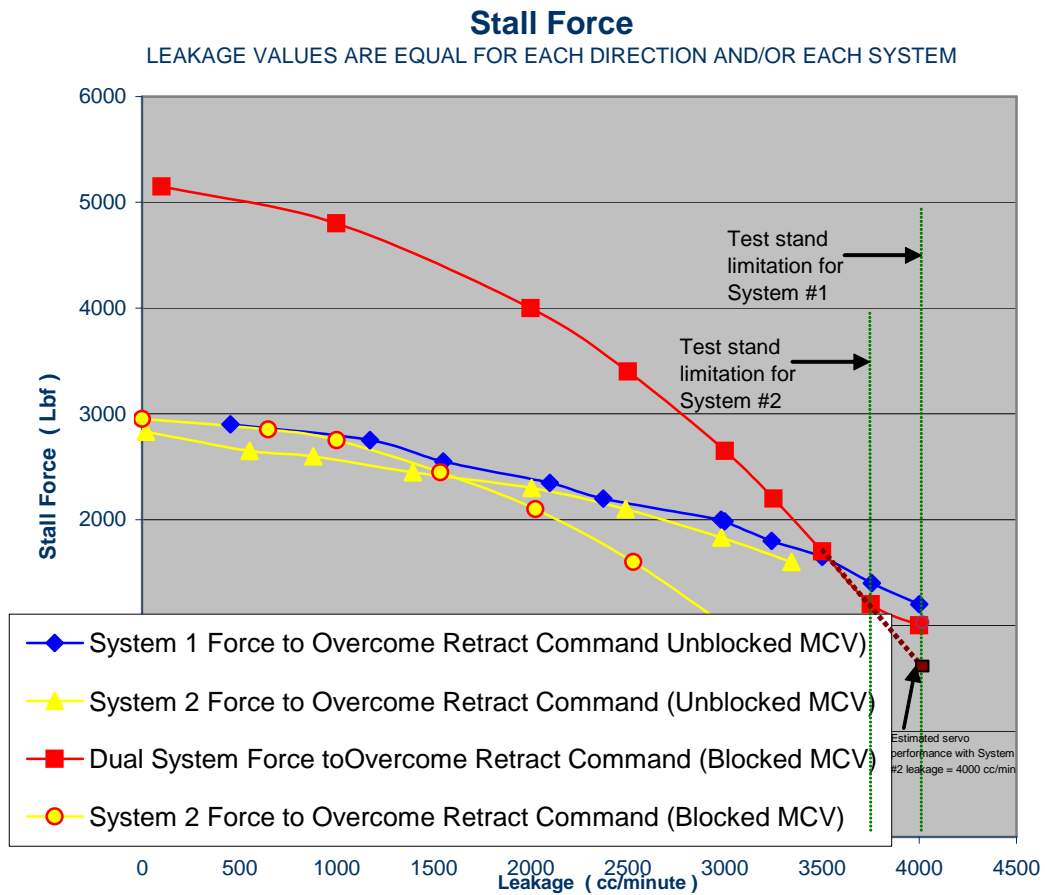
Figure 9. Stall force data

Stall force was observed to decrease as internal leakage increased. A blocked main control valve (MCV) port and higher leakage rates also significantly lowered the stall force. Refer to Figure 9 for example, stall force data.

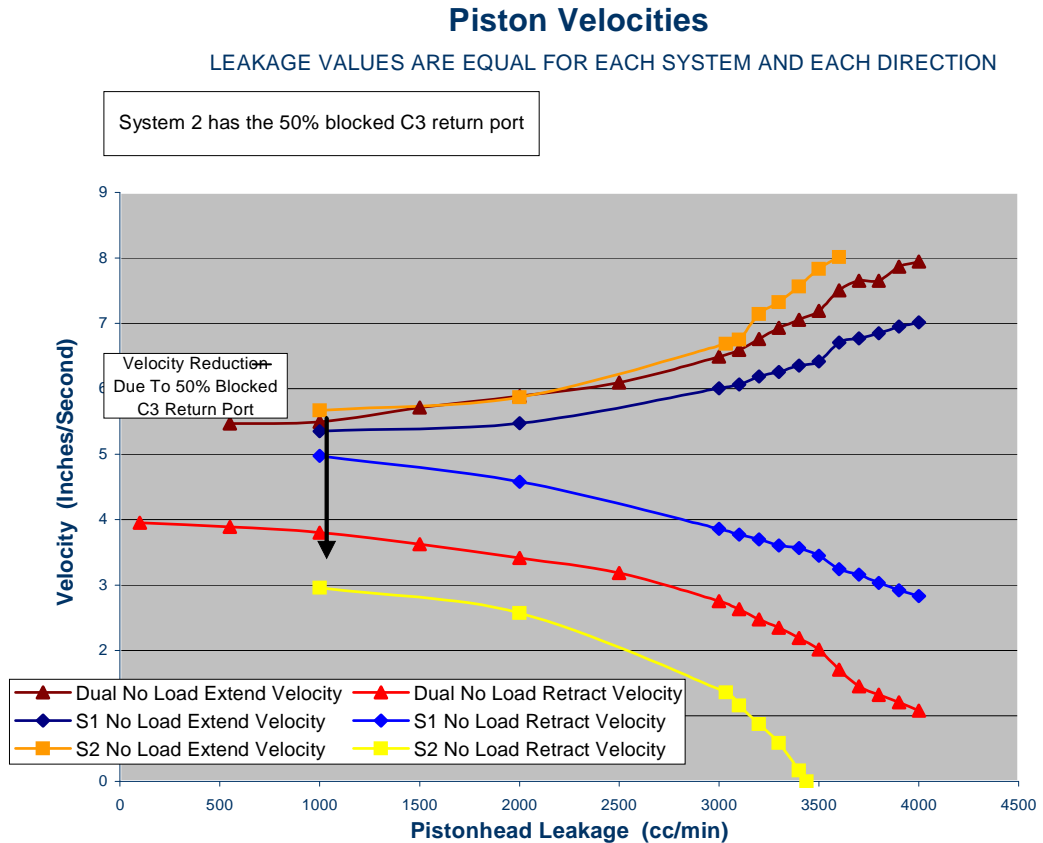
Figure 10. Piston Velocity Data

Piston velocity was observed to decrease in the Retract direction as internal leakage rates increased. Piston velocity was found to increase in the Extend direction as internal leakage increased. A blocked MCV accentuated the magnitude of the velocity change in both directions. Refer to Figure 10 for example, piston velocity data.

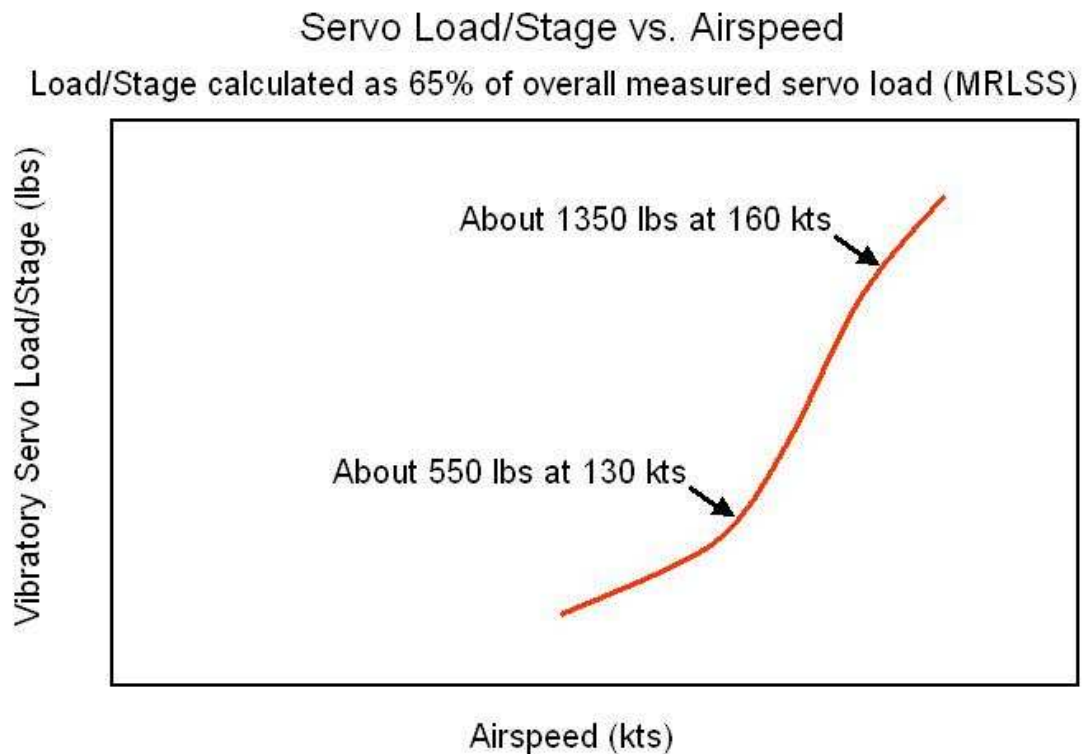
Figure 11. Forward actuator load as a function of airspeed

Data show how actuator loads could increase with airspeed. The effect of airspeed on the loads of the forward actuator is shown in Figure 11 (with proprietary information removed).

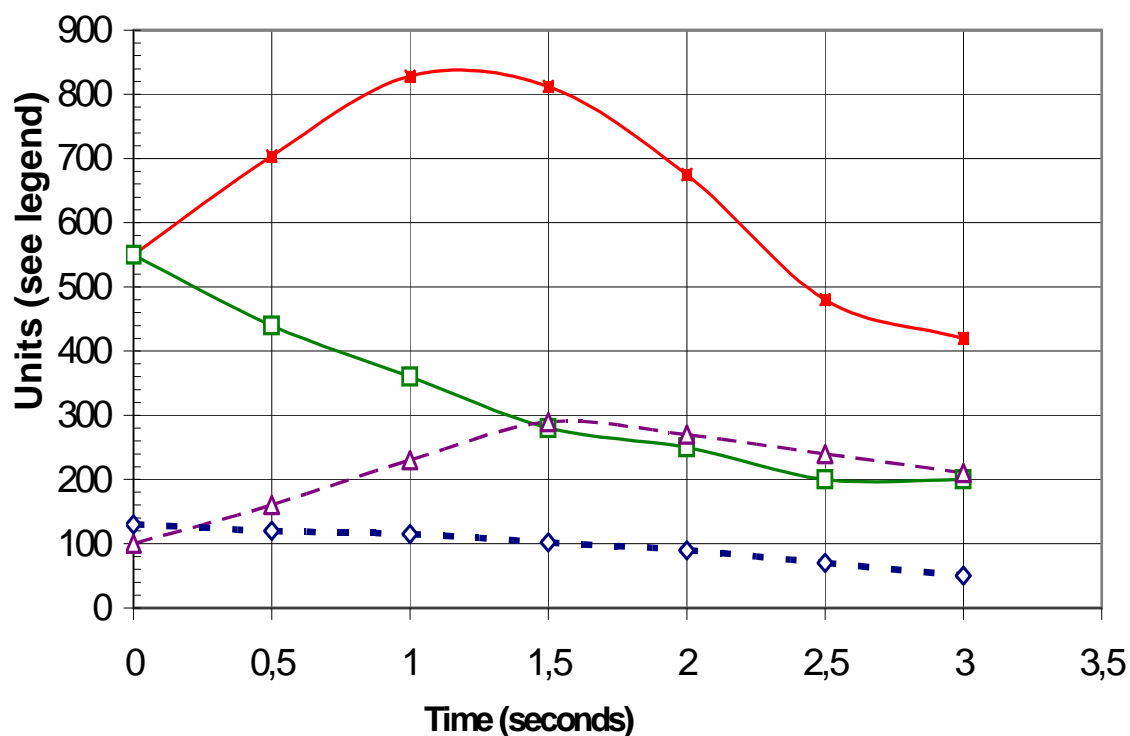
Figure 12. Integrated time history estimate for loads upon the actuator in the helicopter accident flight.

The airspeed and vertical accelerations from the FDR of the accident helicopter were used to produce an estimated profile of total vertical load shown as Figure 11. The total actuator load profile represented an estimate of the tension loads imposed on the actuator by the rotor blades during the initial departure from cruise flight. If the actuator were not capable of resisting the estimated force, the loads could lead to an uncommanded extension.

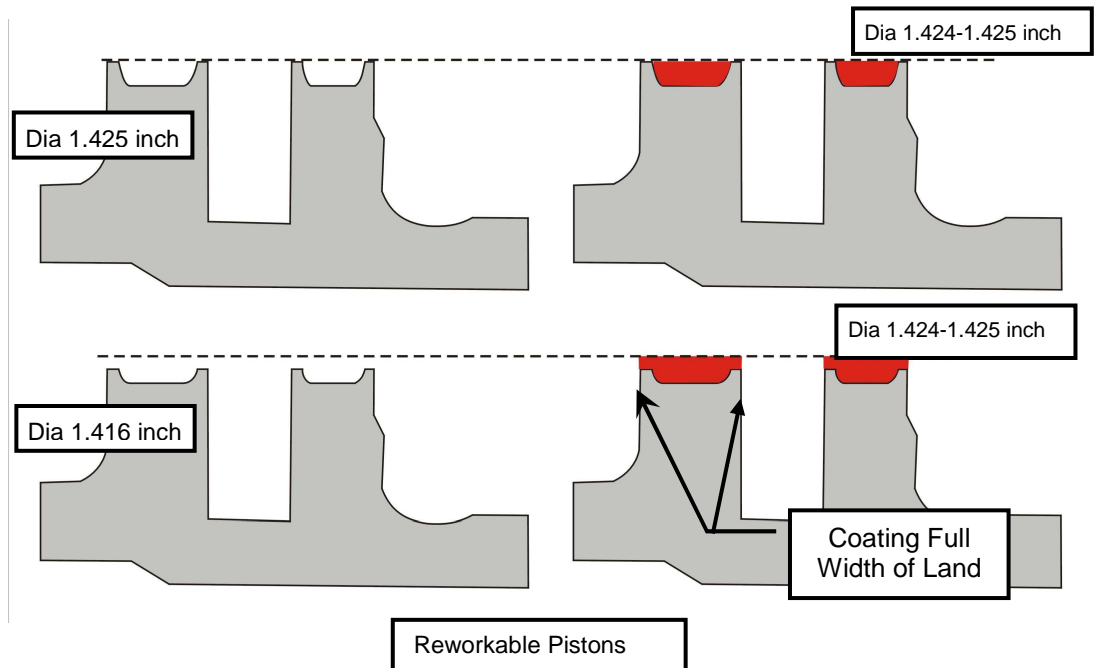
Figure 13. View of section of the piston head lands with plasma coating (red colored)

While it was known that there were dimensional limits on the size of the piston diameter before recoating, it was discovered in the investigation examinations that the lands of the plasma channel could get over sprayed. The over spray was thin and could be separated by lifting, thus starting the chipping process. The over spray of the lands had not been adequately addressed during design and there were no procedures in place to control over spray of the lands during the plasma coating process. For a reworkable piston the allowed diameter is between 1.416 and 1.425 inches at the edges of the trough before coating. As such, when coated and machined to final dimensions, the plasma spray coating can overlap the edges of the lands, as depicted below. In the middle of the trough the coating will still be between 0.010 and 0.0125 inch thick but

depending on starting diameters it can be between 0.000 and 0.0045 inch thick at the edges. This condition is referred to as a “full width coating”.
