Investigation report

B 4/2000 M

Mv. MARIA VG, incident at Sea of Bothnia off Pori, November 7, 2000

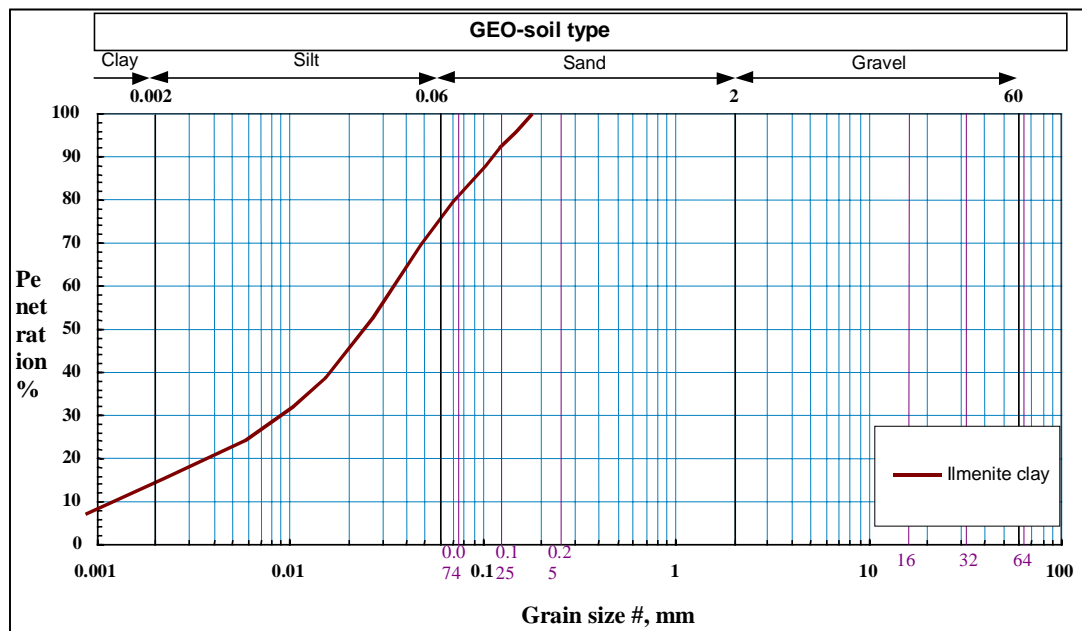
Figure 5 Grain size of ilmenite clay

Properties of ilmenite clay. The grain size distribution of ilmenite clay according to the analyses of Kemira Pigments Oy is shown in Figure 5. According to the report of the producer, the transportation (wet) density of ilmenite clay is between 2.0-2.5 t/m³. The solid density of the ilmenite clay examined by the analysis of VTT is 3.16 t/m³ and the optimum values for the dry density and water content are 18.6 kN/m³ (1.89 t/m³) and 19.5 % . The corresponding wet density is 22.2 kN/m³ and 2.26 t/m³.

VTT determined the Transportable Moisture Limit = TML for the batch of samples taken on March 14, 2001 by the Proctor-C method (described in the IMO Code for Bulk Cargo, Appendix D). The value for the Transportable Moisture Limit (TML) was 22.7 % (mass). At this value, the dry density of the mass is about 1.56 t/m³. The corresponding wet density (at 70 % saturation) is about 1.92 t/m³.
